**Technical Support Document
For Record Of Decision
Cape Lisburne, AFS**

INSTALLATION RESTORATION PROGRAM
TECHNICAL SUPPORT DOCUMENT
FOR RECORD OF DECISION
CAPE LISBURNE
LRRS SITE

Prepared By
Woodward-Clyde Consultants
701 Sesame Street
Anchorage, AK

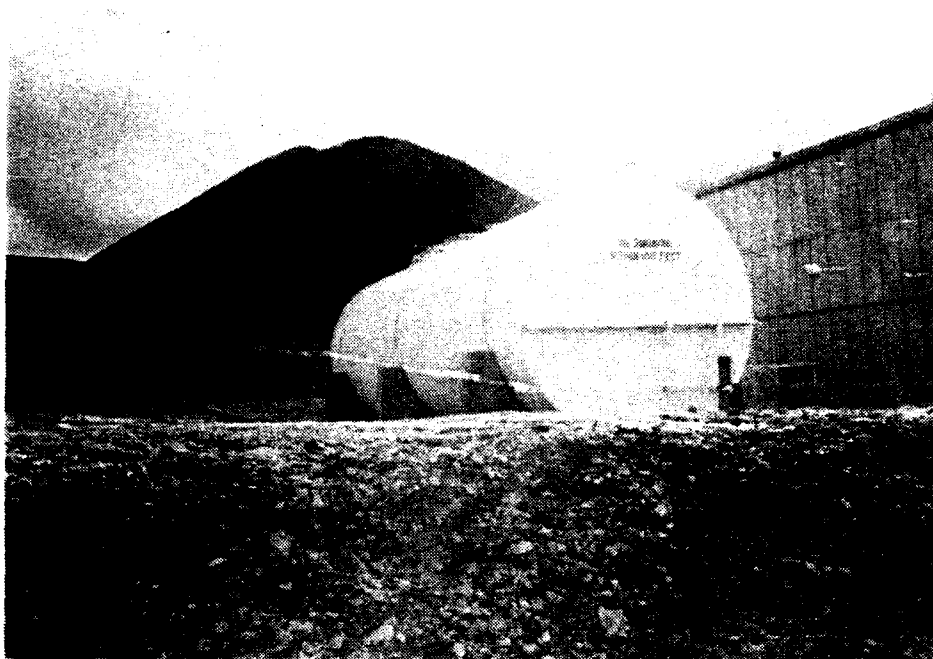
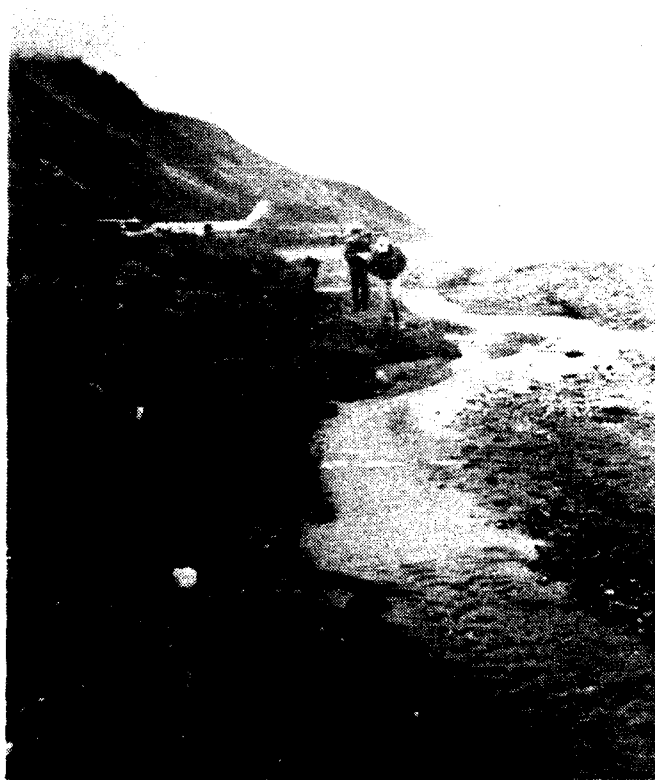
Spill/Leak Nos. 1 and 2
Cape Lisburne AFB

The location of Spill/leak No. 1 (site 1) has been reworked since the spill occurred in 1980. The site is currently occupied by a large fuel tank within a diked enclosure (Figure 3). No evidence of contamination was observed by the field survey team.

Spill/leak No. 2 occurred in the apron area of the runway. No trace of contamination was noted on the apron; this area has been regraded since the spill occurred in 1982. However, the drainage ditch paralleling the runway (Figure 3) exhibited stained sediments ($<18 \text{ cm}^2$) and a slight petroleum odor. The drainage ditch is a high energy system and it is unlikely that significant contamination remains.

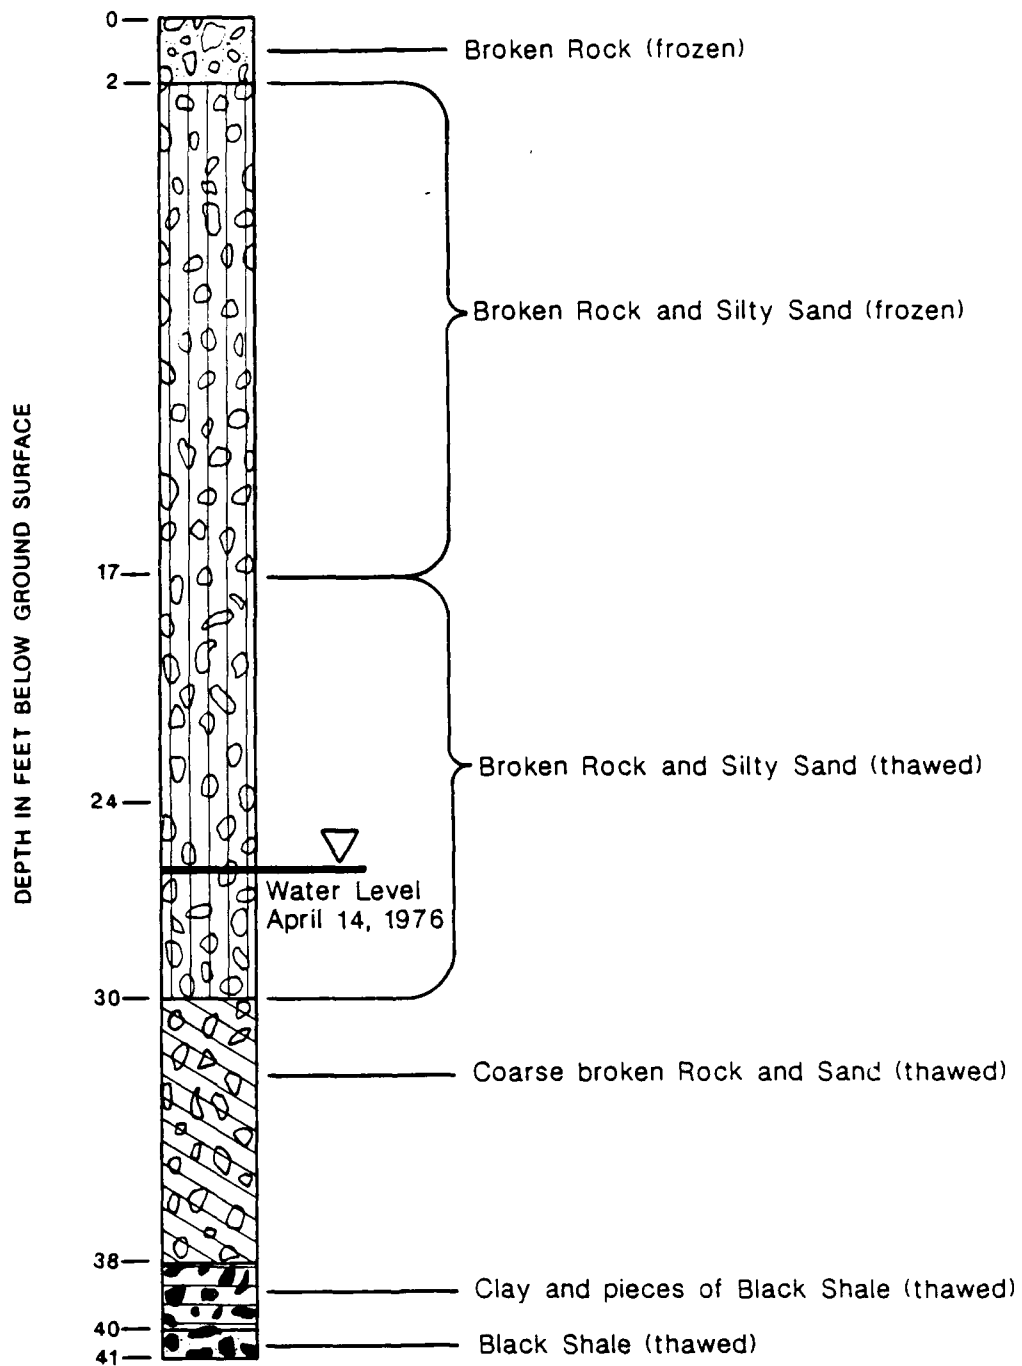
CAPE LISBURNE AFS WELL LOG

The Lower Camp area is underlain with up to 15 m of talus and alluvial fan deposits. The deposits are deepest in the creek bed. A well log taken near the Lower Camp shows depth to bedrock at 12 meters (Figure 7).

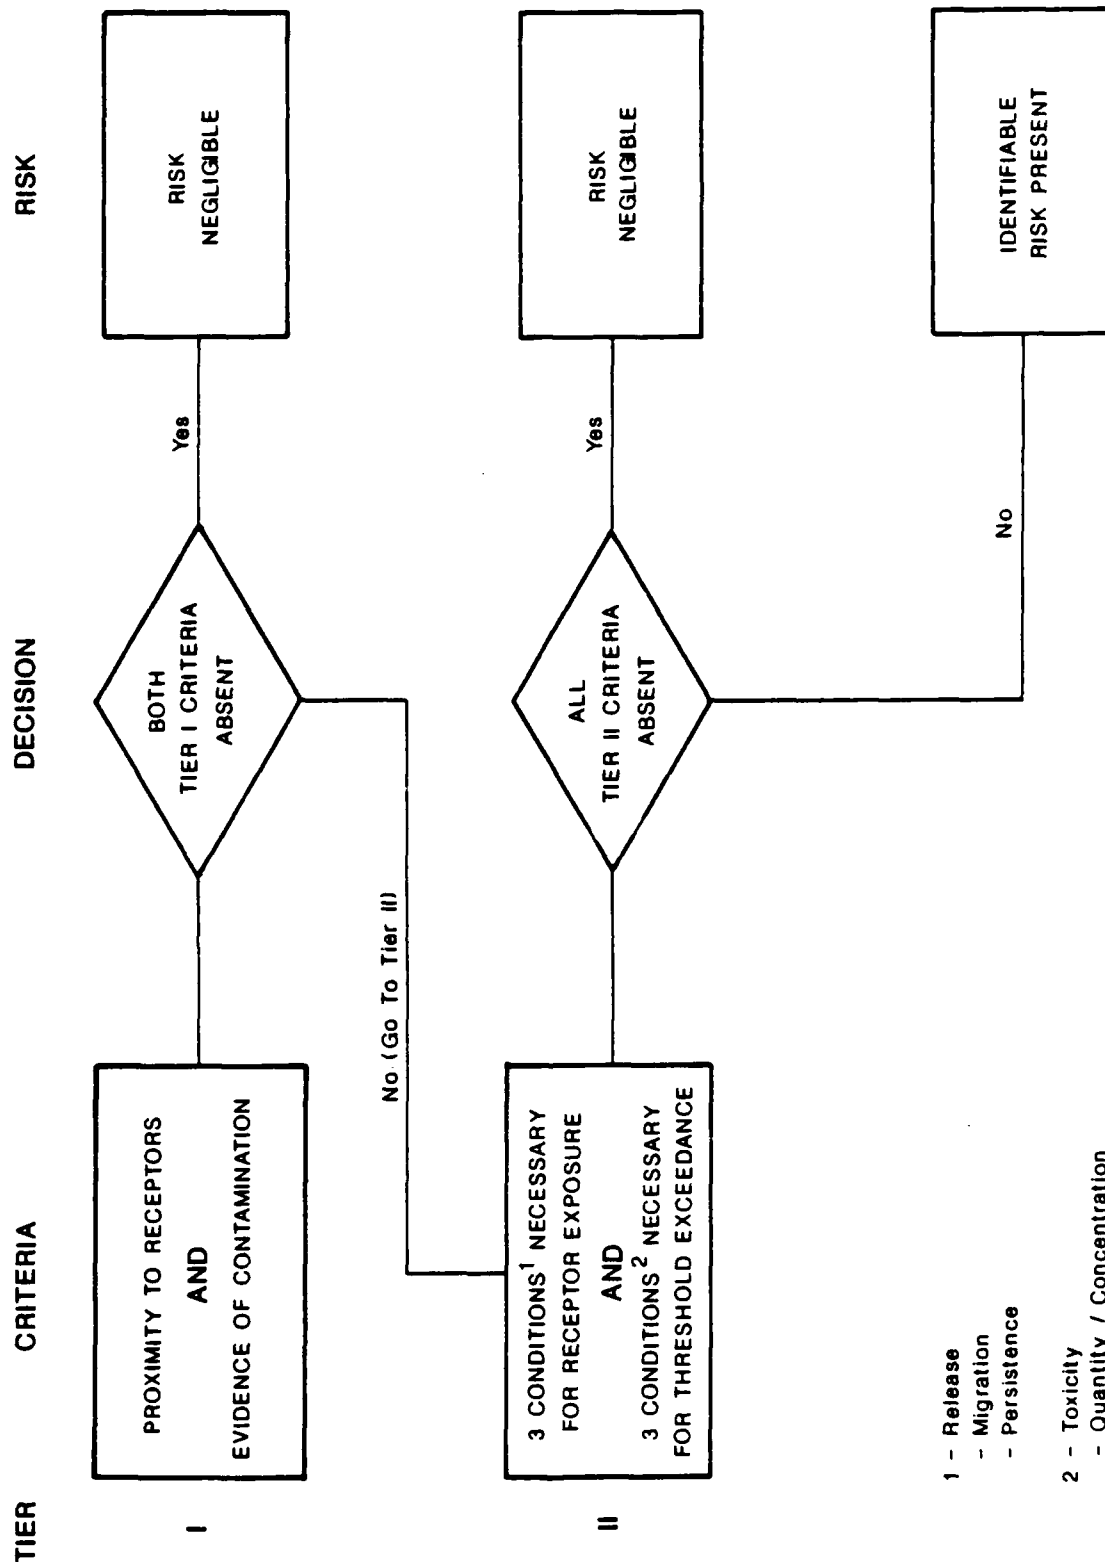
FLOW DIAGRAM SHOWING
TWO LEVELS OF RISK SCREENING
AND CRITERIA FOR DECISION
MAKING AT EACH LEVEL

For the purposes of assigning risk levels to a site, a two-tiered hierarchical decision scheme is employed (see Figure 8). At tier I, an initial screening of the presence of contaminants and the proximity of sensitive receptors is made. This determination is made by reviewing historical records, observations from the site visit, and published reports or data. If the available evidence does not indicate that contaminants have been release at the site and if the site is not close to sensitive receptors, then the probability of risk is considered negligible. In this case a no further action alternative will be recommended. However, if it is concluded that the site is, or possible has been, contaminated with hazardous or toxic substances or if the site is in close proximity to sensitive receptors, the screening proceeds to tier II. The approach to tier II is deductive. First, receptors and the conditions necessary for exposure must be identified. Second, the conditions necessary for exceedences must be established. These two types of conditions constitute a basic definition of risk at each site. Then the actual conditions at the site are compared to this definition. In actuality, all the specified conditions must be present for significant risk to exist. If one condition is absent, than it could be argued that risk is necessarily negligible. However, the risk screening procedure used here is conservative in that it assumes a negligible risk only if all the conditions are absent. If all the necessary conditions are absent, then a negligible risk is clearly deduced. Likewise, if the status of a specified condition cannot be determined at a site but there is no reason to suspect that it exists, and all other conditions are absent, the site will be assumed to have negligible risk. If one or more of the conditions are present or suspected, then the site will be said to represent some identifiable level of risk.
